Failure Analysis of OH-58 Kiowa Warrior Drive Gear Shafts

ARL-TR-3827

June 2006

The objective of this report is root cause determination for the 15-hp spare drive gear failure.

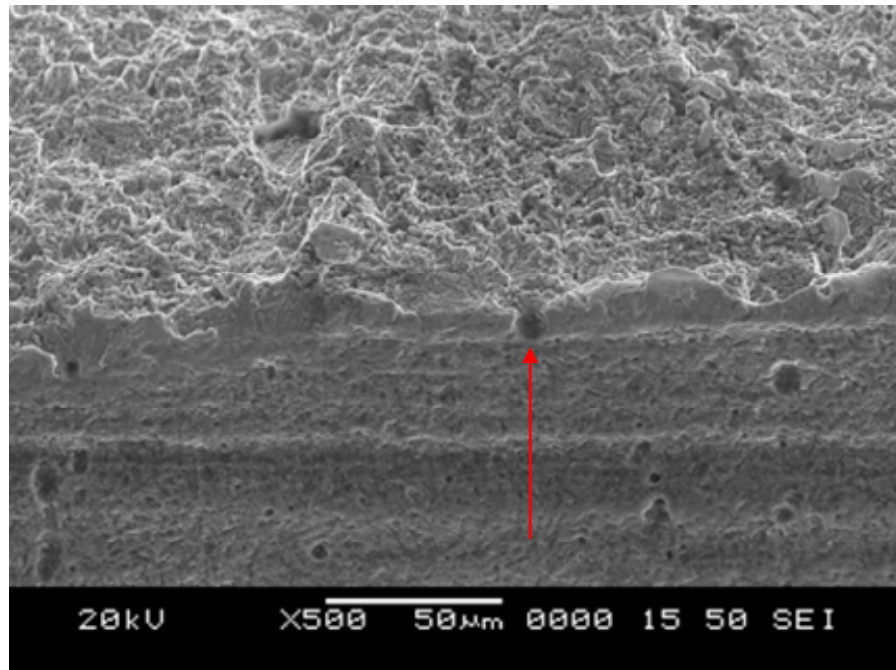
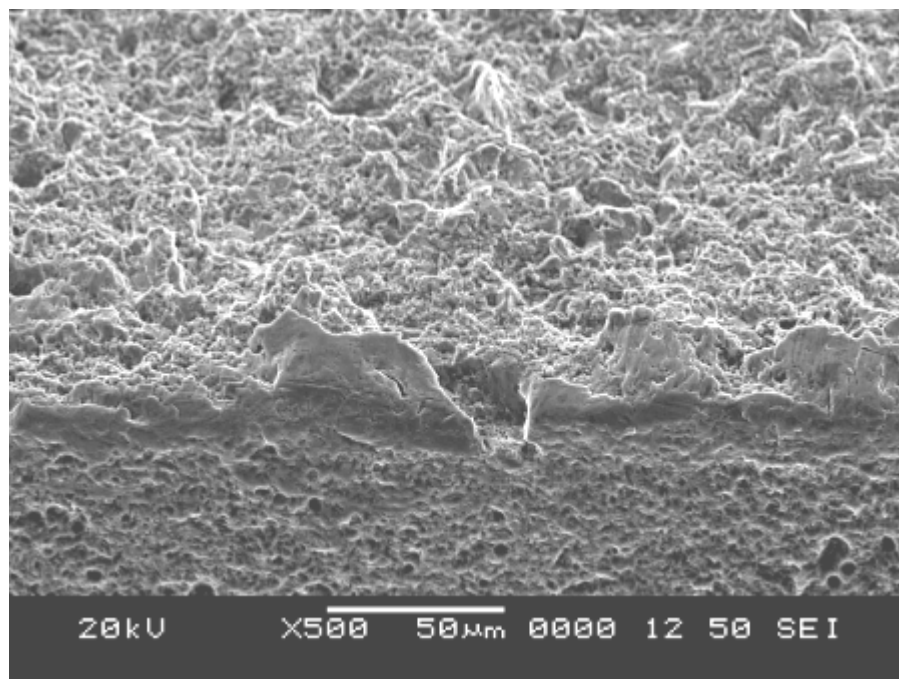
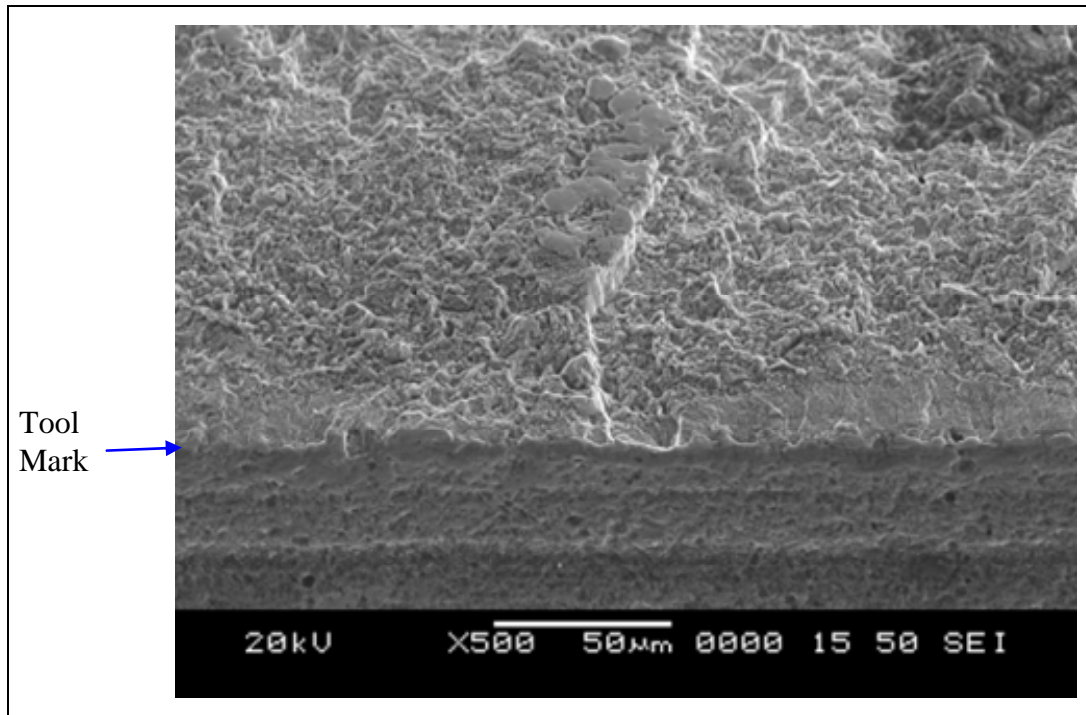
Tooth 4 had multiple origin sites (both pits and tool marks), which are shown in figures 45–47. There was a pit that led to cracking that can be observed on both the tooth and gear fracture halves (figures 45 and 46).

Figure 45. Tooth 4 drive side primary pit origin.

Figure 46. Tooth 4 drive side primary pit origin, gear fracture half.

Figure 47. Tooth 4 drive side.

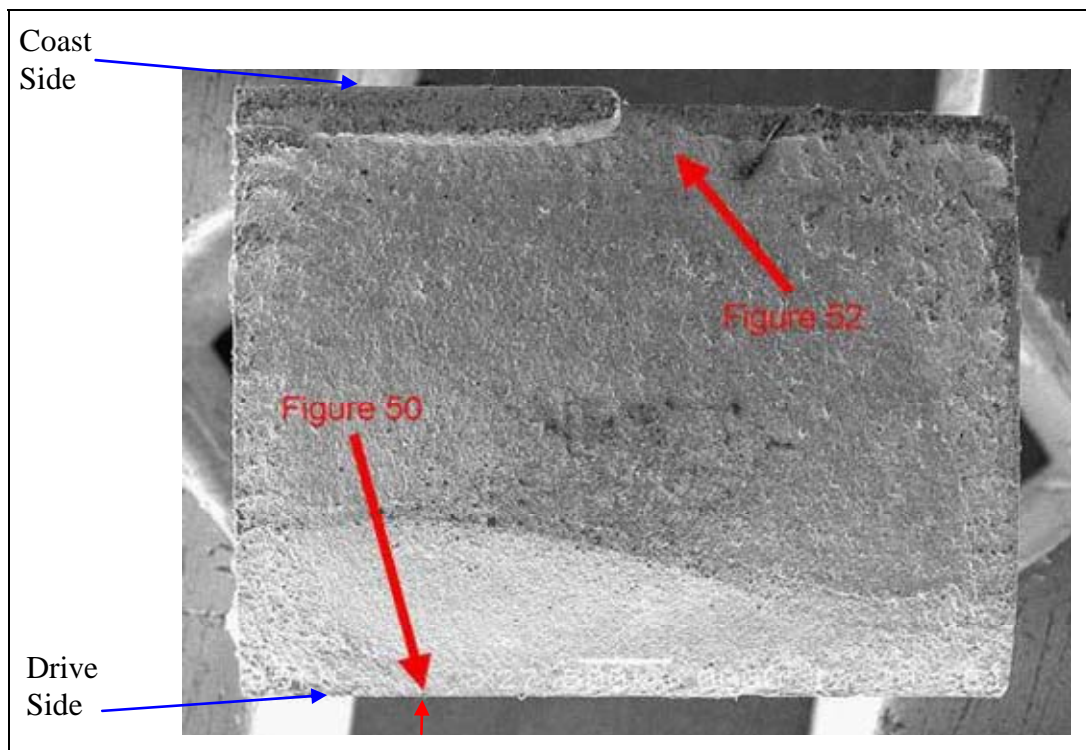
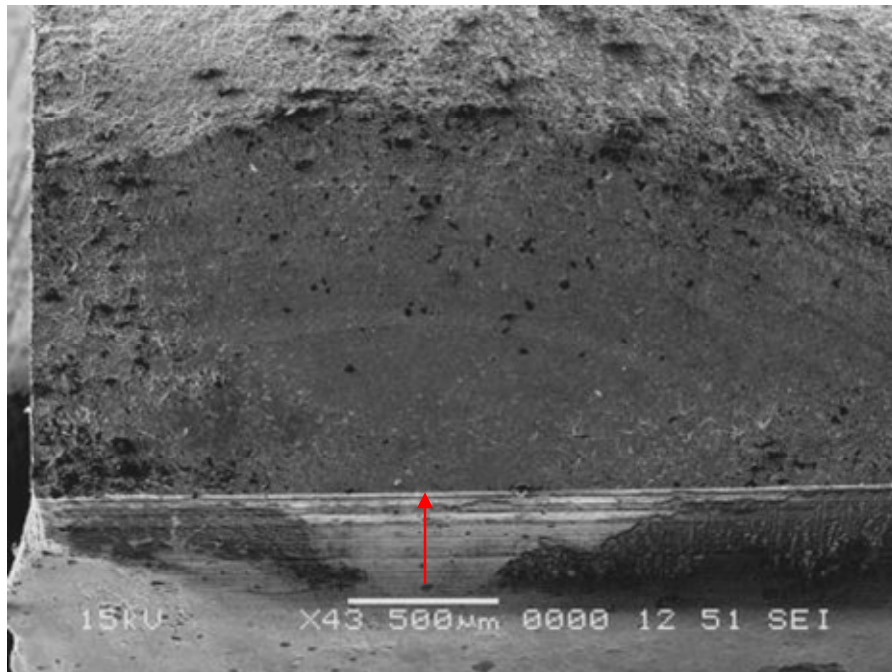
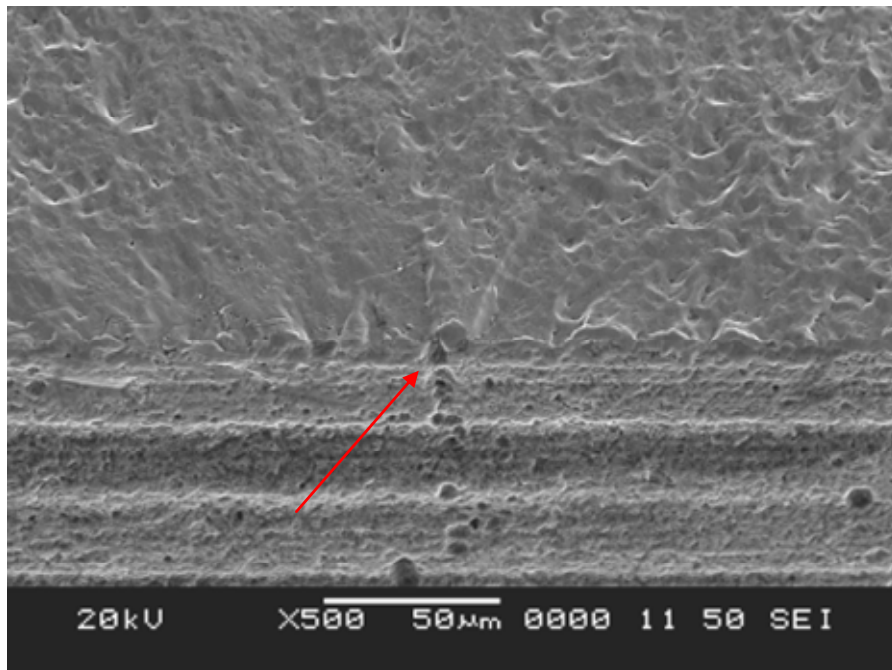
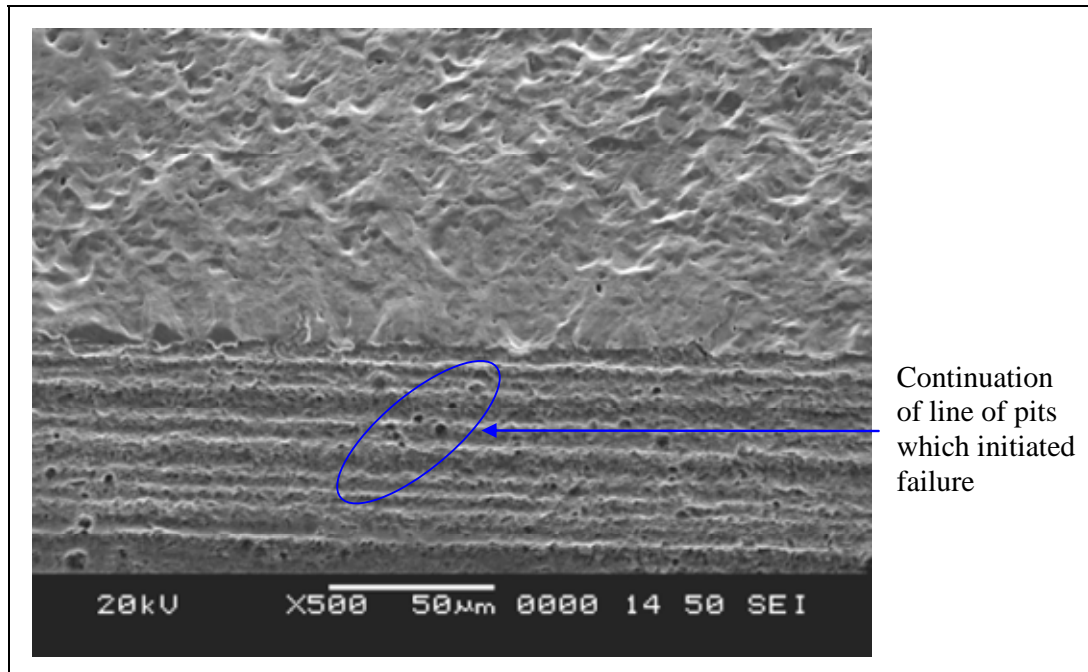
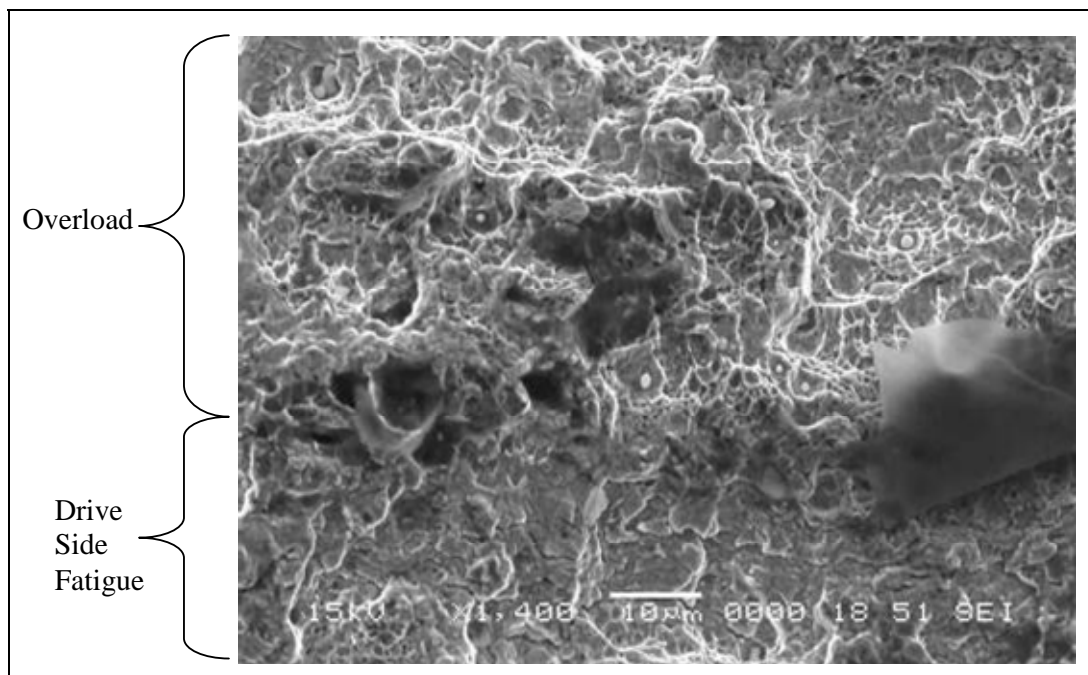
Tooth 28 is shown in figures 48–52. The fracture was remarkably similar to tooth 1; both fractures possessed a primary pit origin (drive side), initiation and propagation from the coast side, and a very small overload region. Figures 49–51 show the origin of fatigue on this primary failure that can be traced to a line of pits including the pit which initiated failure.

Figure 48. Tooth 28 fracture surface.

Figure 49. Tooth 28 drive side, primary origin.

Figure 50. Tooth 28 drive side, primary pit origin.

Figure 51. Tooth 28 drive side origin site, gear fracture half.

Figure 52. Tooth 28 fracture surface, transition to overload at top.

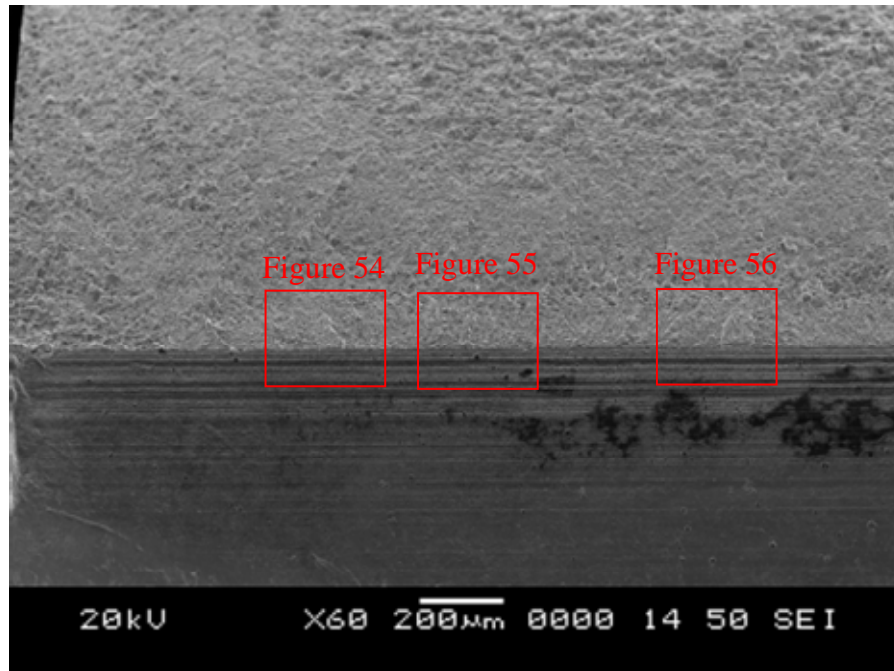
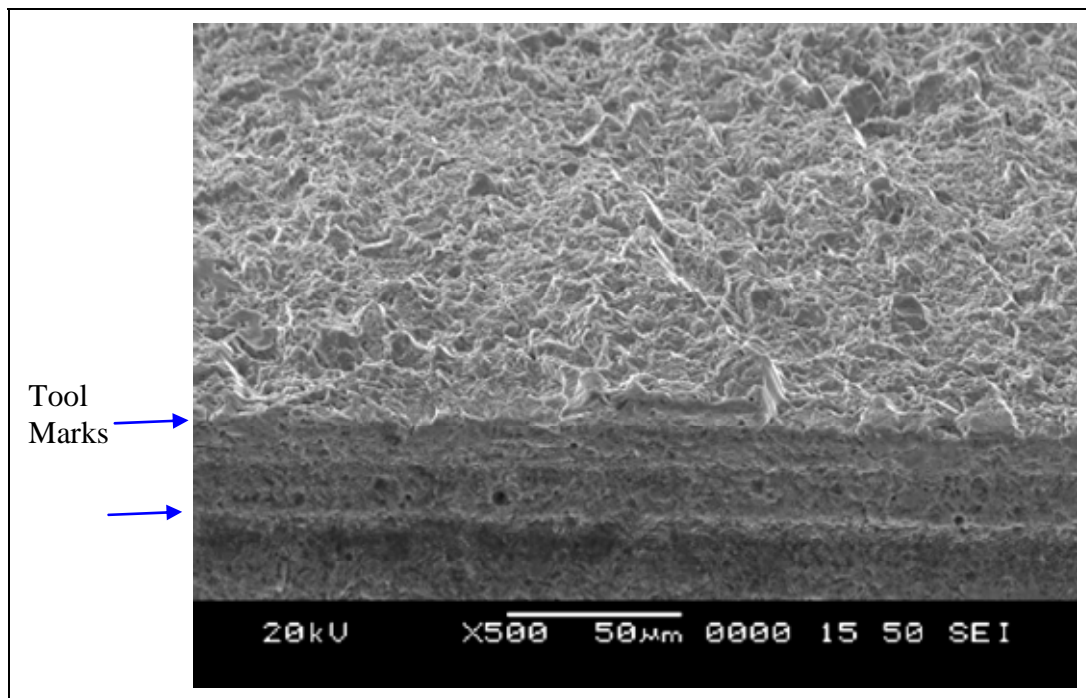
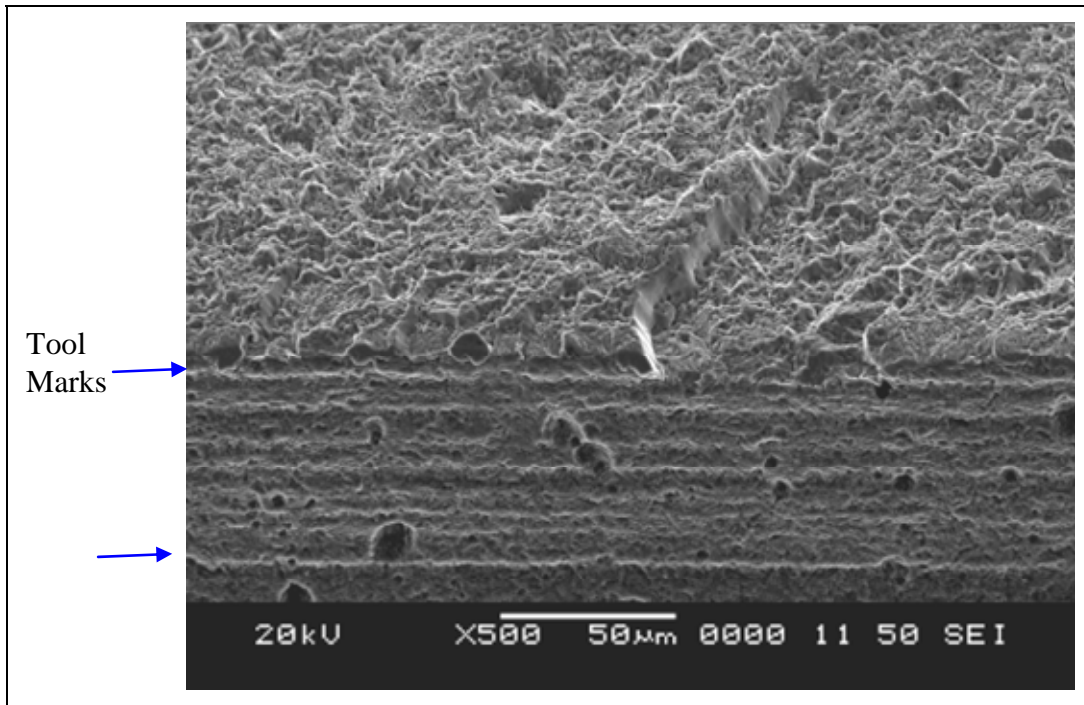
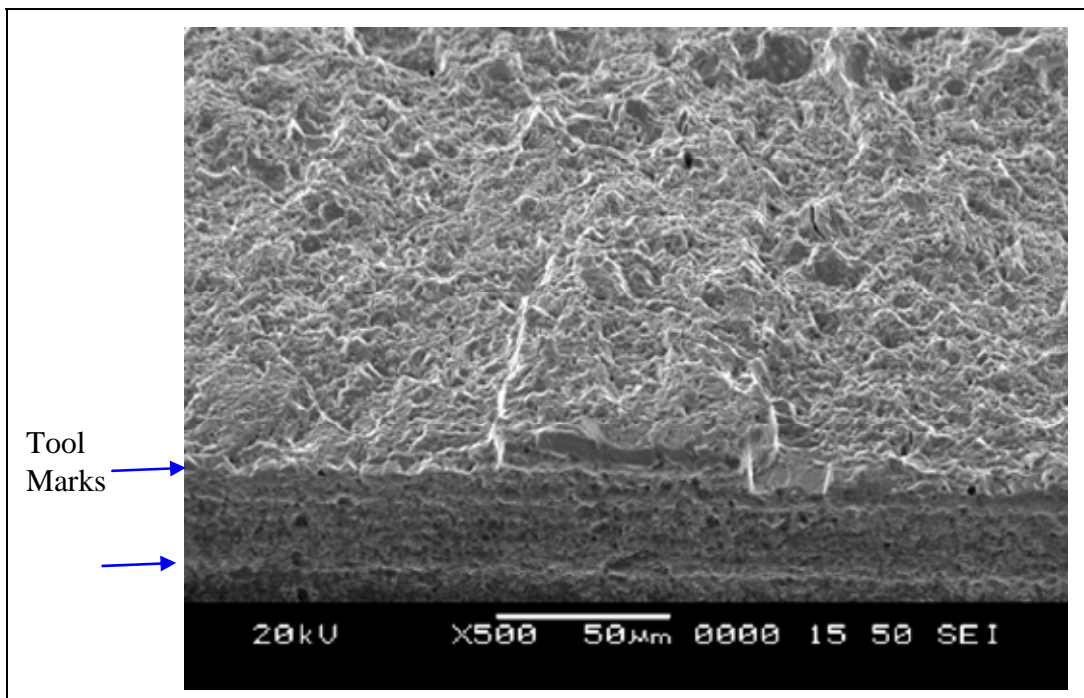
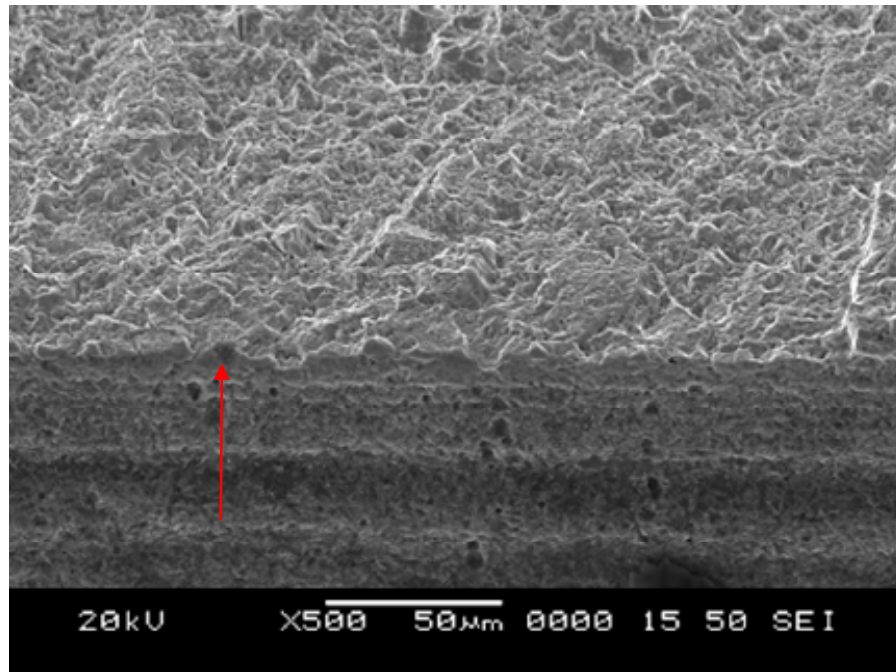
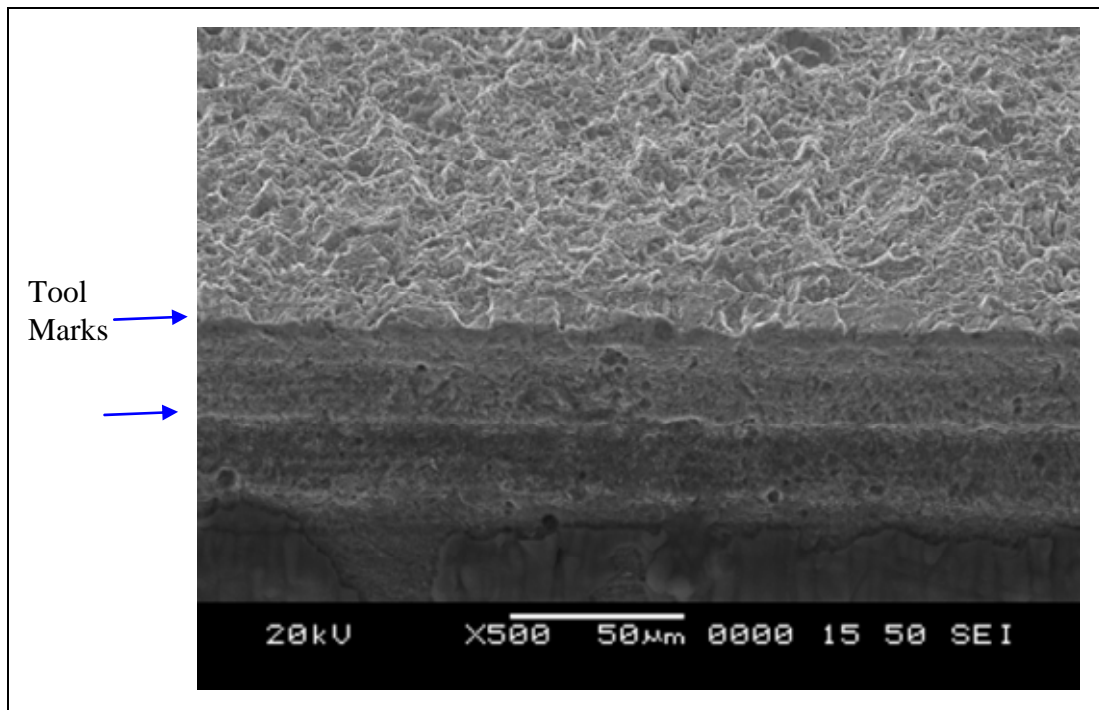
Figures 53–58 show the fracture surfaces associated with tooth 29. Failure originated at multiple points along the drive side, which are seen on both the tooth and gear fracture halves, including both pits and tool marks.

Figure 53. Tooth 29 drive side origin area.

Figure 54. Tooth 29 drive side origin, site no. 1.

Figure 55. Tooth 29 drive side origin, site no. 2.

Figure 56. Tooth 29 drive side origin, site no. 3.

Figure 57. Tooth 29 drive side, primary pit origin.

Figure 58. Tooth 29 drive side origin, site no. 4.

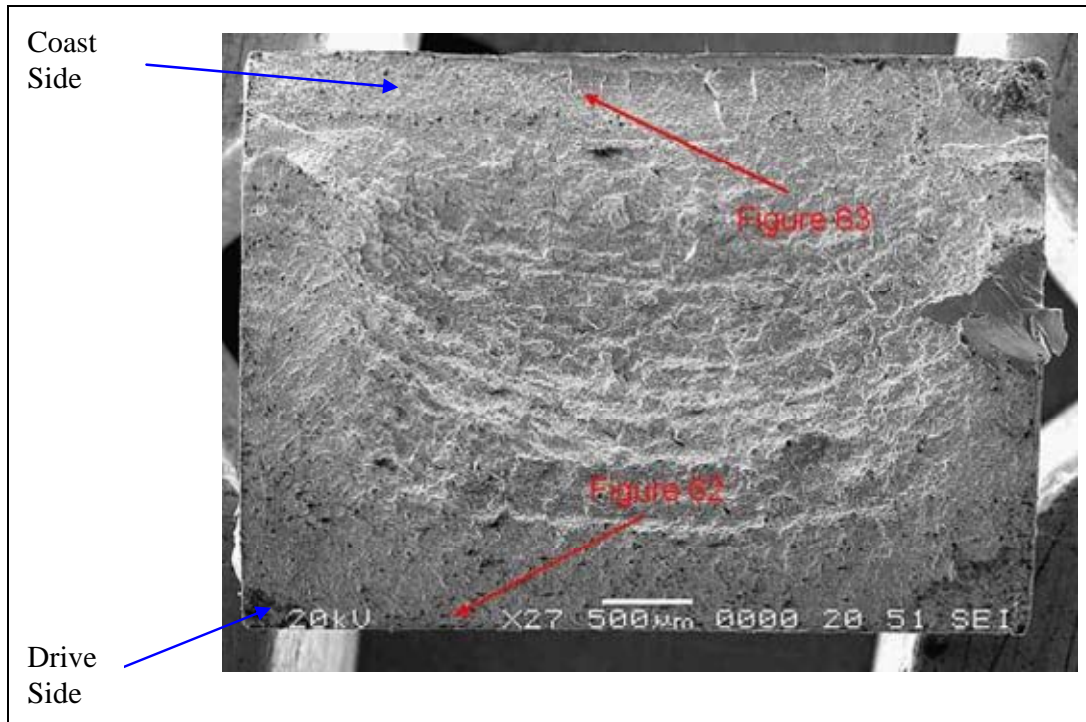
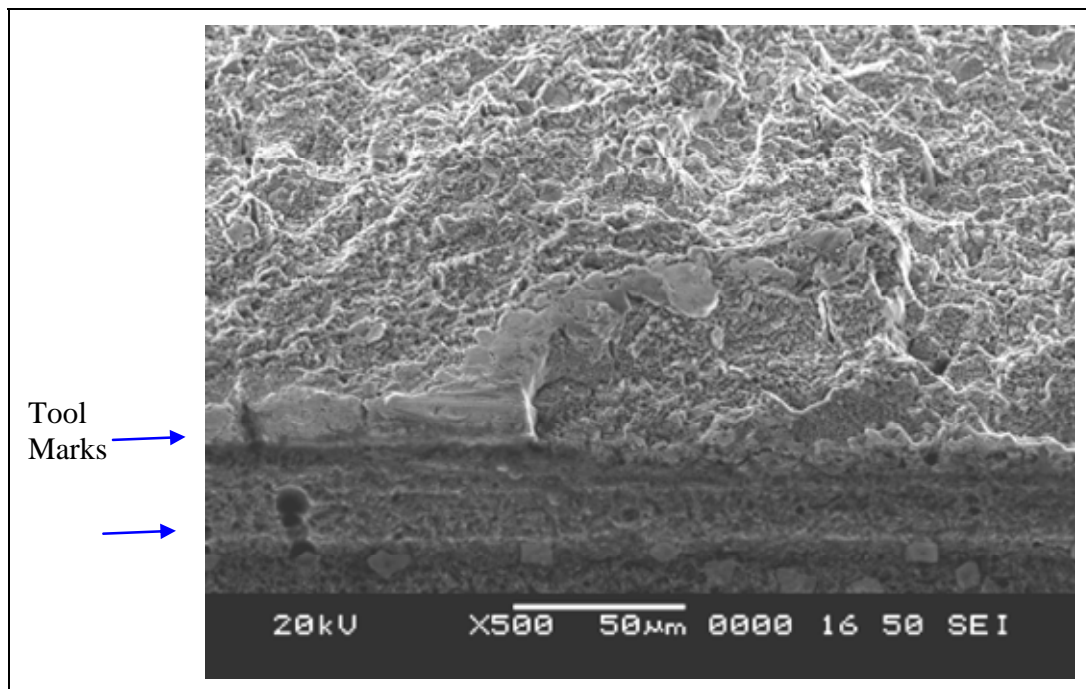
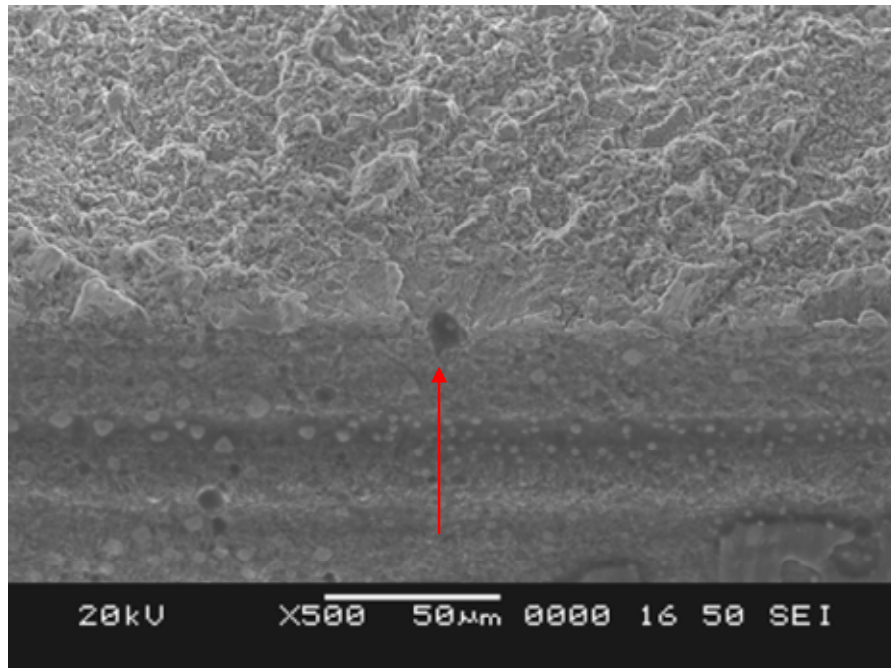
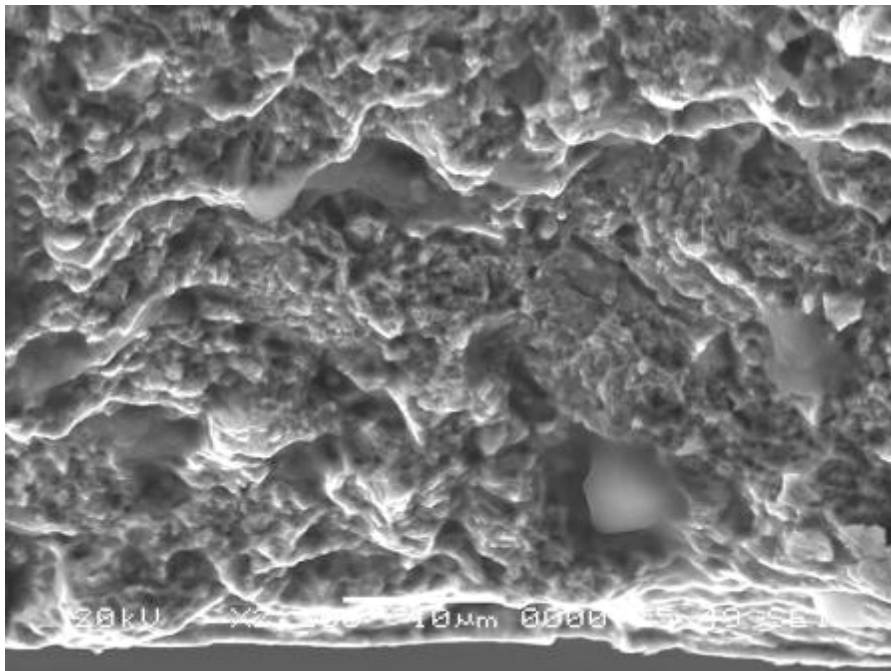
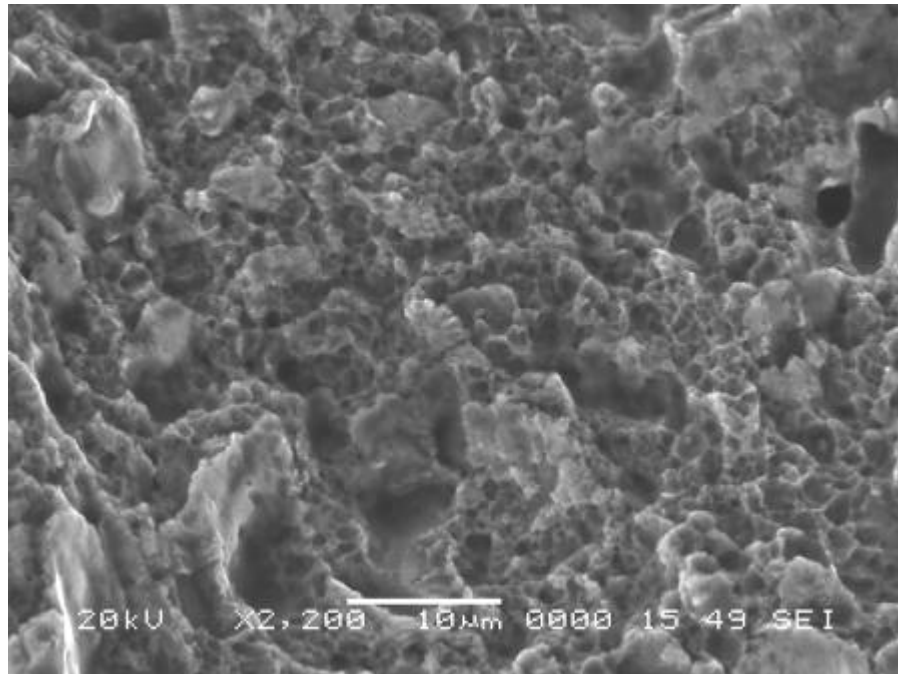
Tooth 30 is shown in figures 59–63. Multiple origins were found on the drive side, shown in figures 60–61.

Figure 59. SEM tooth 30 fracture surface.

Figure 60. Tooth 30 origin, gear fracture half.

Figure 61. Tooth 30 pit origin, gear fracture half.

Figure 62. Tooth 30 fracture surface, drive side.

Figure 63. Tooth 30 fracture surface, coast side.

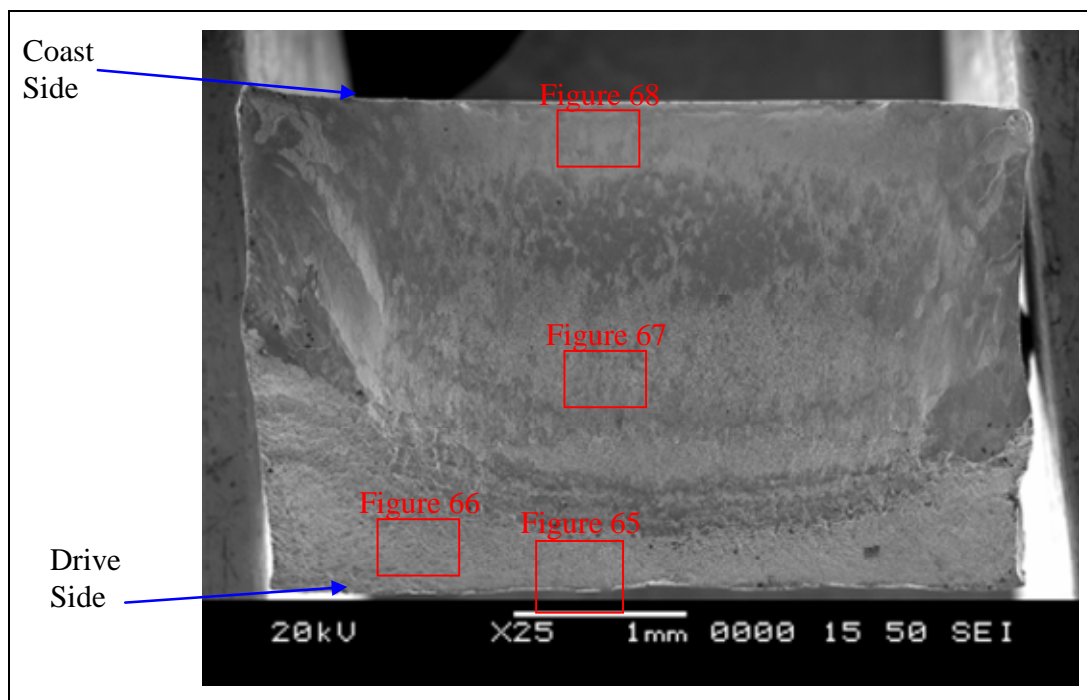
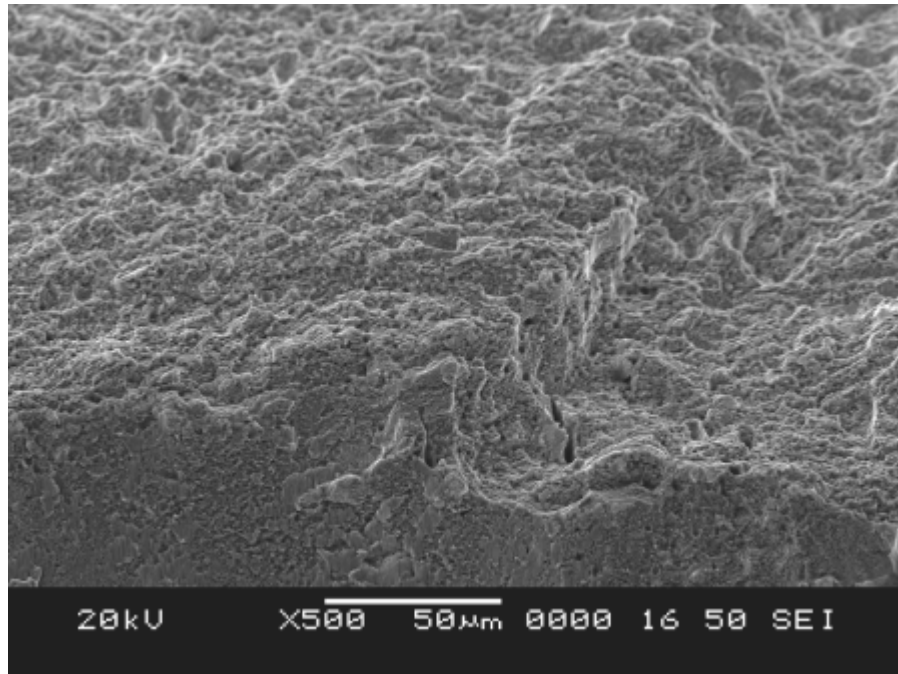
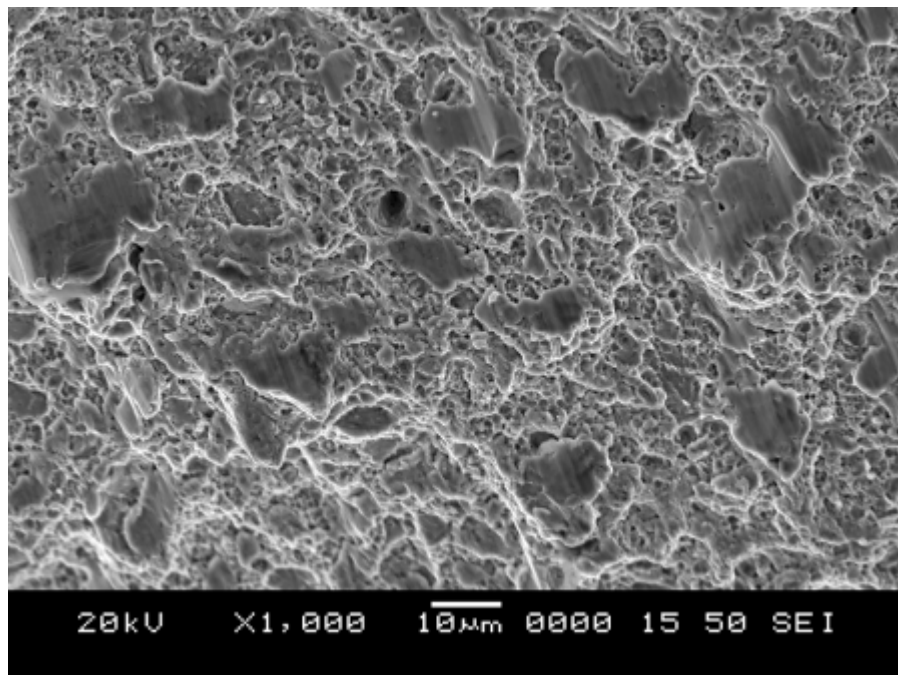
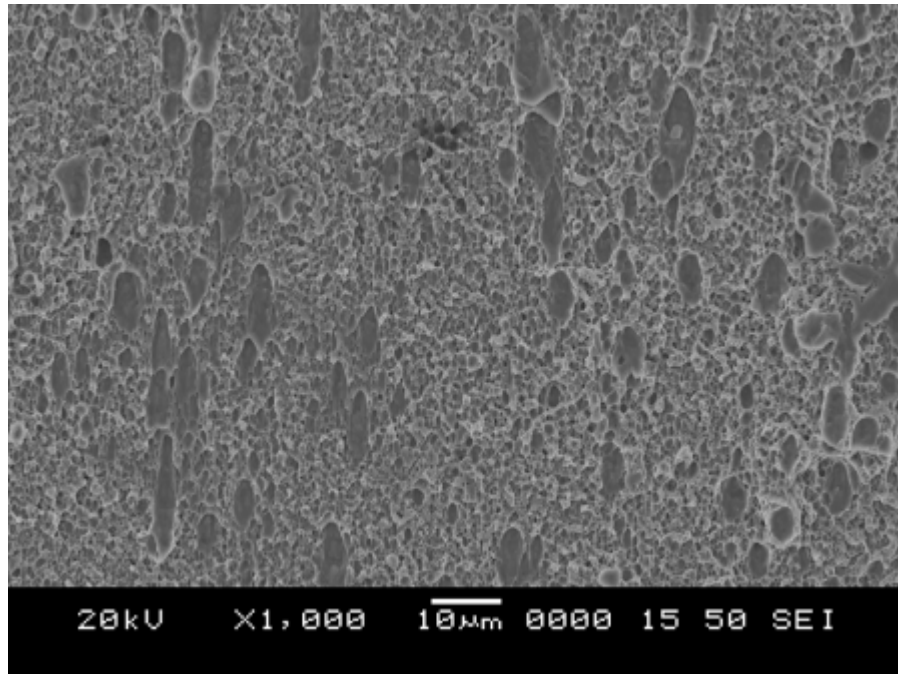
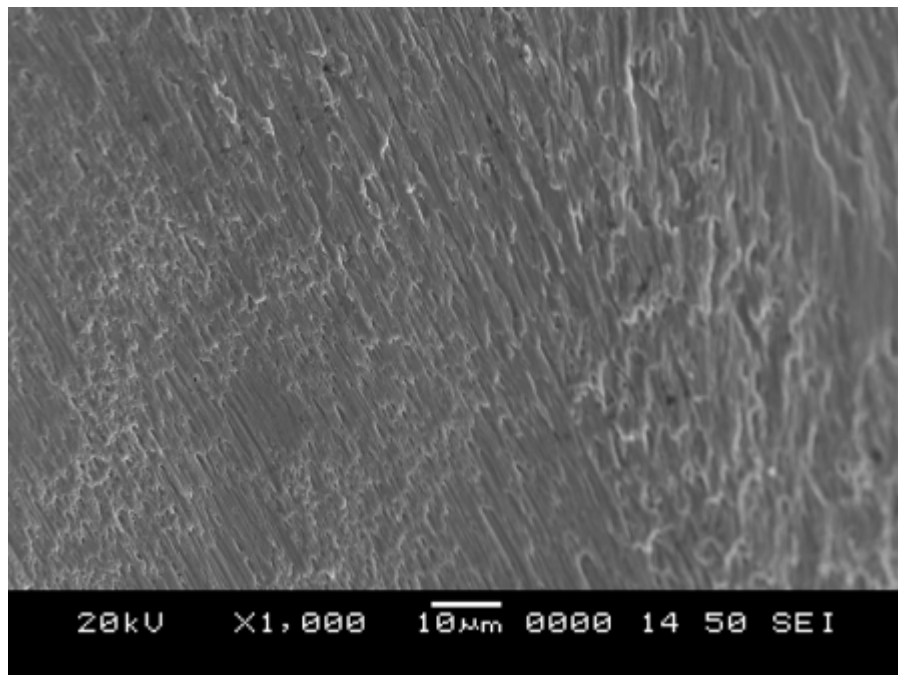
The fracture surface generated by the low cycle fatigue failure of tooth 31 is presented in figure 64. The drive side origin is shown in figure 65. The fracture morphology includes a small amount of mixed mode fracture (figure 66), but is dominated by cyclic overload in the middle of the tooth (figure 67) and near the coast side (figure 68).

Figure 64. SEM tooth 31 fracture surface.

Figure 65. Tooth 31 origin.

Figure 66. Tooth 31 fracture surface.

Figure 67. Tooth 31 fracture surface, showing cyclic overload fracture.

Figure 68. Tooth 31 fracture surface, ductile overload.

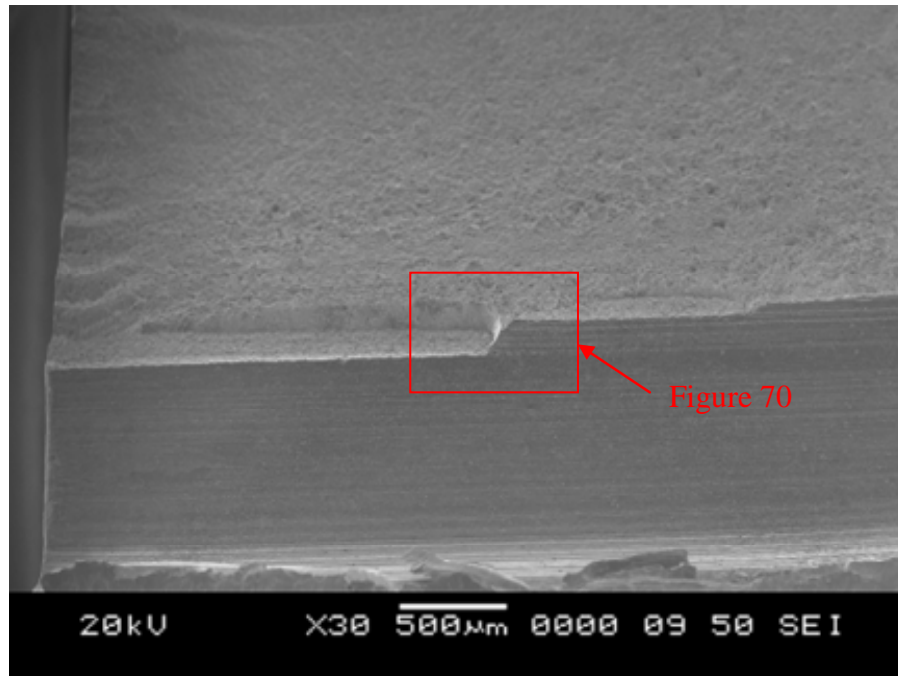
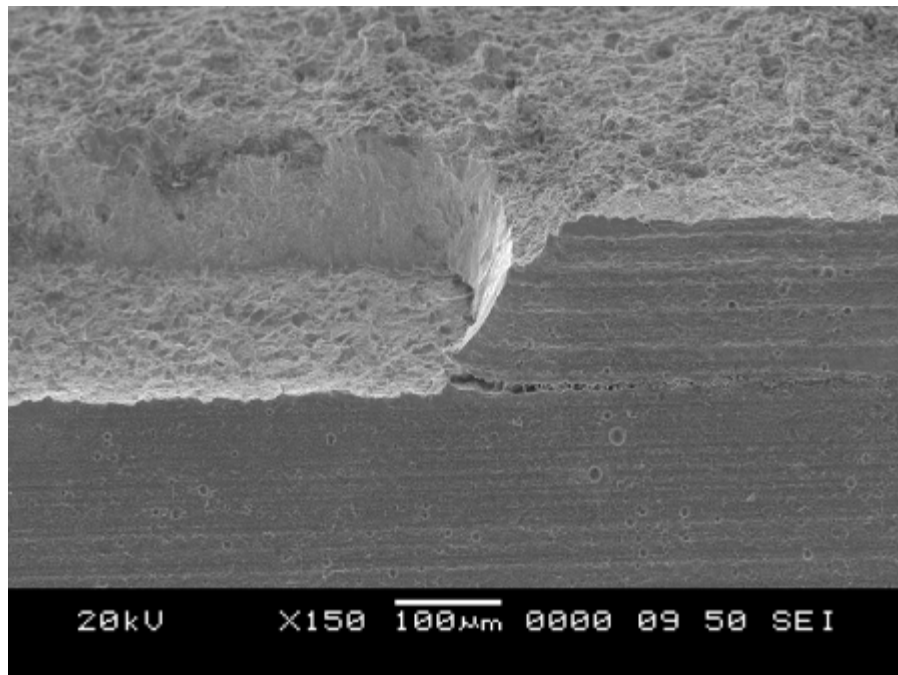
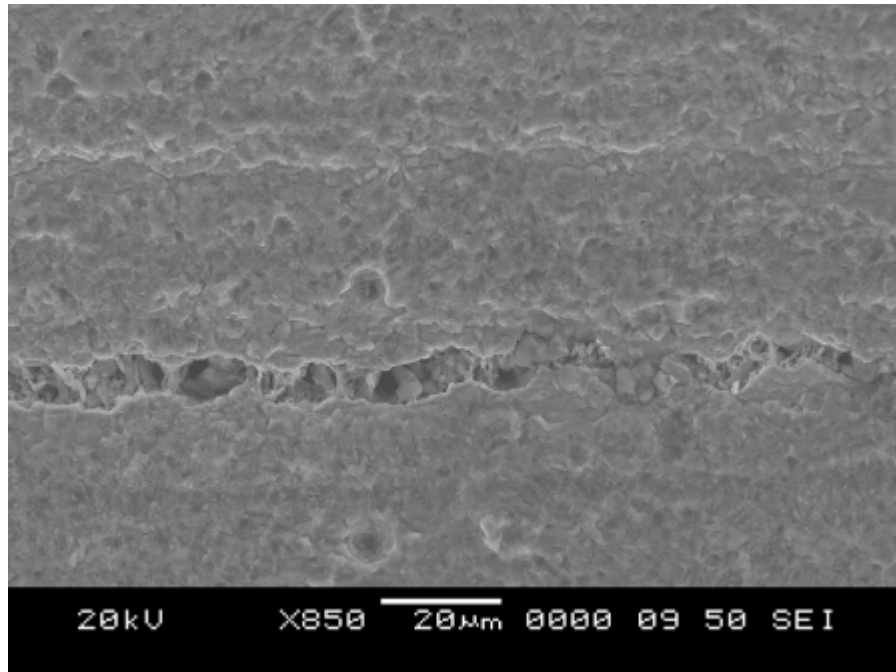
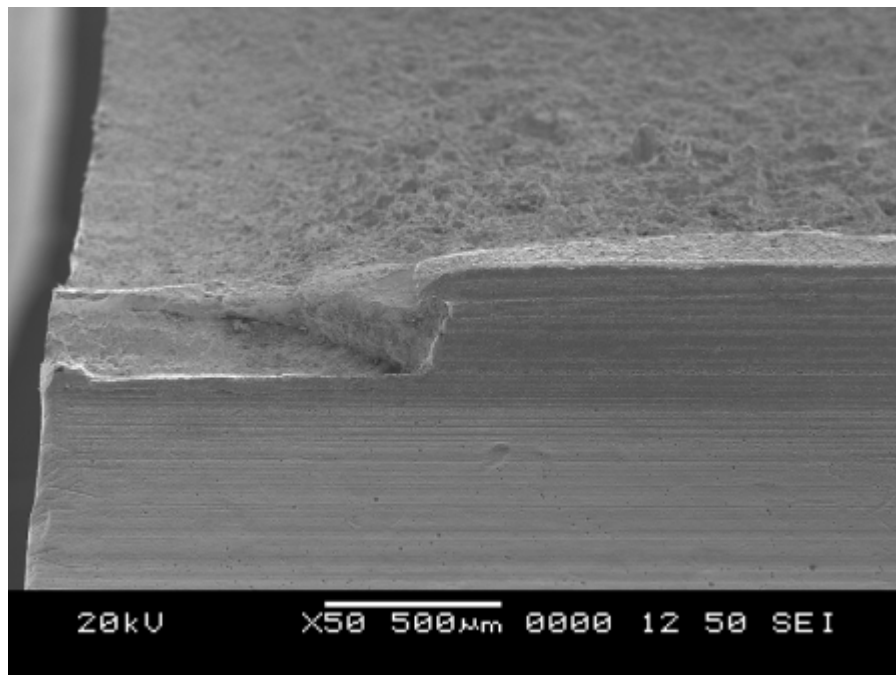
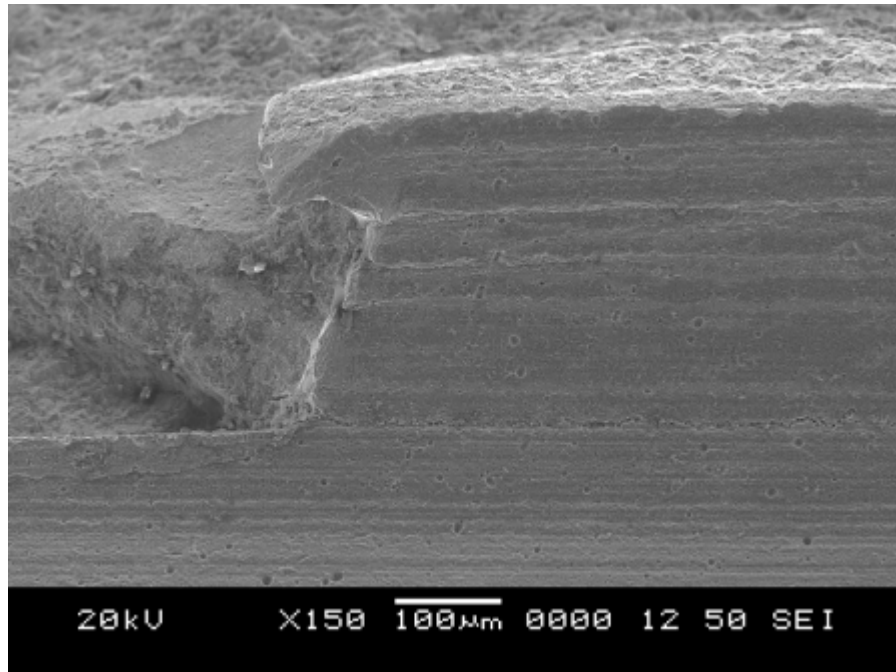
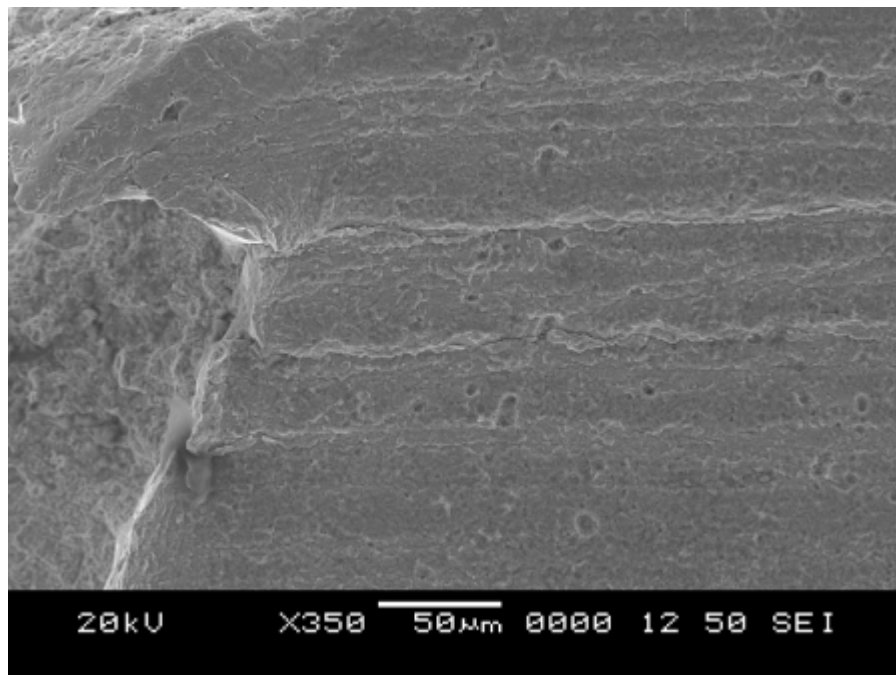
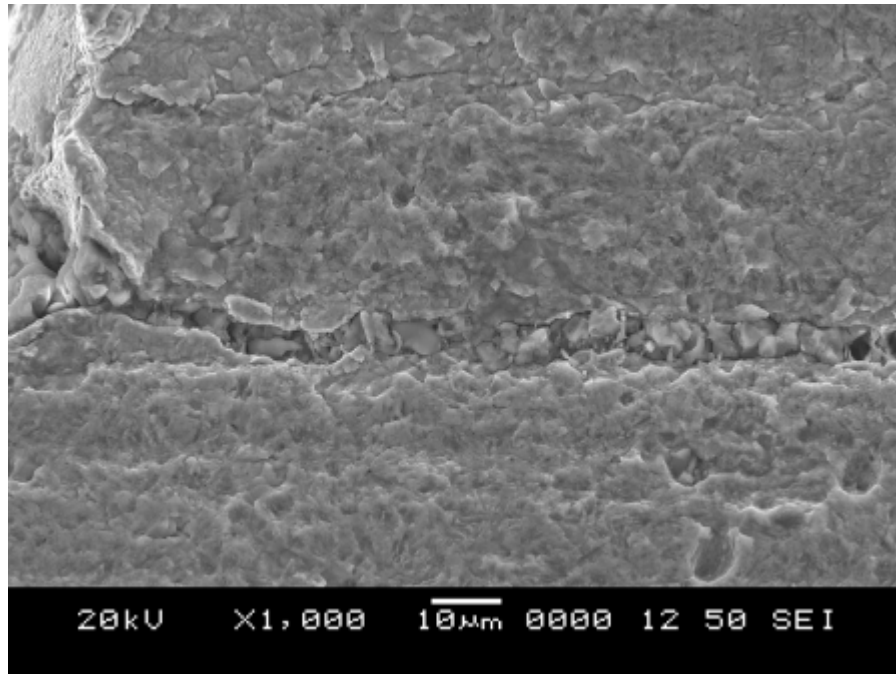
Cracking originating from coast side tool marks is shown in figures 69–75.

Figure 69. Tool marks, tooth 28 root, gear half.

Figure 70. Coast side tool marks, tooth 28 root, gear half. (Note the undercut parallel to tool marks.)

Figure 71. Tooth 28 root, gear half, coast side cracking along tool marks.

Figure 72. Tooth 29 root, gear half, coast side tool marks.

Figure 73. Tooth 29 root, gear half, coast side tool marks.

Figure 74. Tooth 29 root, gear half, coast side tool marks, cracking along tool marks.

Figure 75. Tooth 29 root, gear half, coast side, cracking along tool marks.

- Identify and eliminate the source of the pitting.
 - Eliminate or reduce the magnitude of the tool marks present in the tooth root fillet.
-

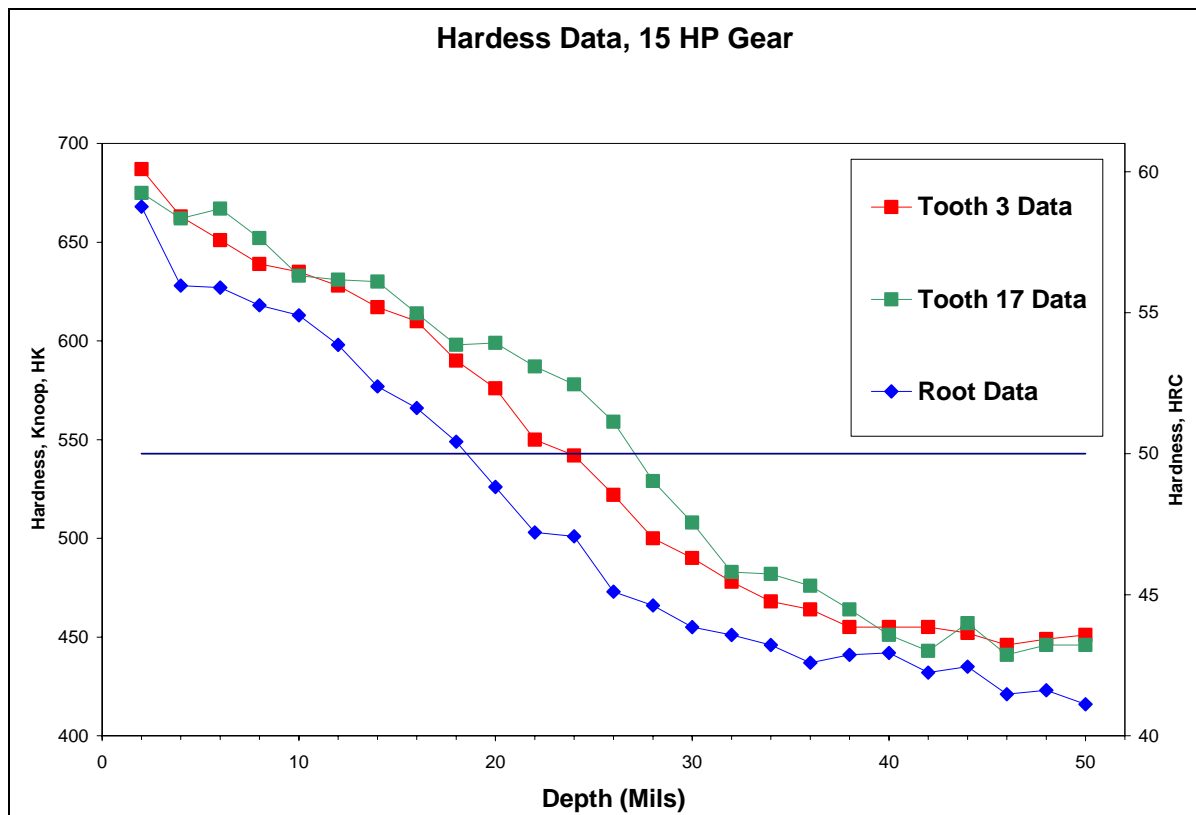
Figure 76. Hardness data tooth and root profiles.

Hardness measurements were provided by Redstone Technical Test Center. They were made at the tooth root and at the face (near the pitch line) using an Instron Model Tukon 2100 microhardness tester. Effective case depth (EFD) (defined as the depth at which hardness drops to 50 Hardness Rockwell C-scale [HRC]) was found to be approximately 0.026 in at the pitch line and 0.018 in at the root. Hardness data for the profile and root are given in tables 1–3 and shown in figure 76.

The EFD was determined to be 0.018 in at the root and 0.026 in at the pitch diameter. The EFD was defined as the depth at which a value of 50 HRC is obtained.

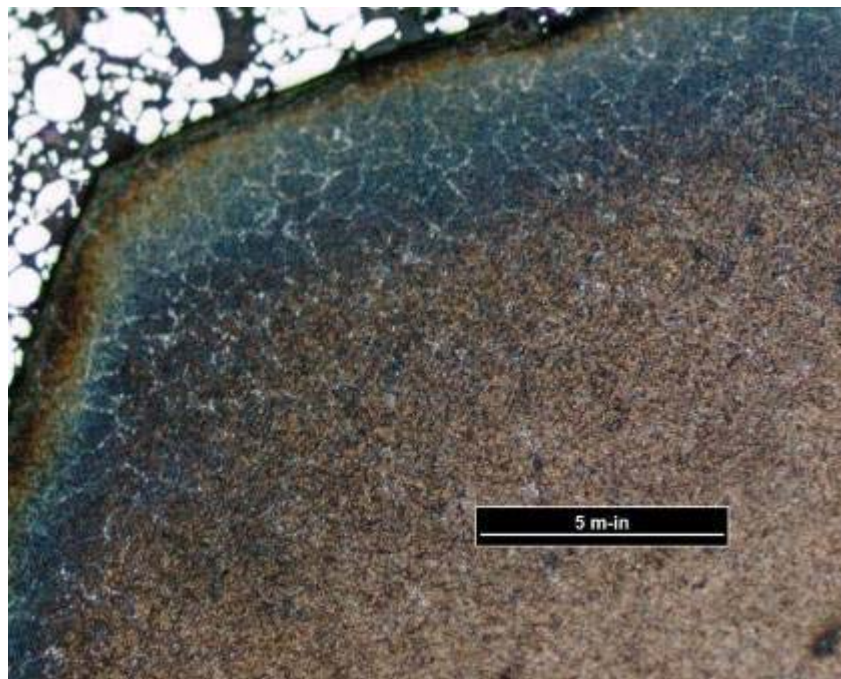
Cross sections of the gear and two fractured teeth (teeth 28 and 29) were prepared. These were ground and polished through 0.02- μm colloidal silica and subsequently etched with a 2% nital solution. No microstructural abnormalities were observed. Formation of continuous carbide networks was ruled out (figure 77).

Figure 77. Metallographic cross section demonstrating absence of continuous carbide networks.
